## **Salerno (Devil's) Lake Shoreline Inventory Project**

Prepared by: Devon Fowler, 2012-2013

For: The Salerno (Devil's) Lake Cottagers' Association

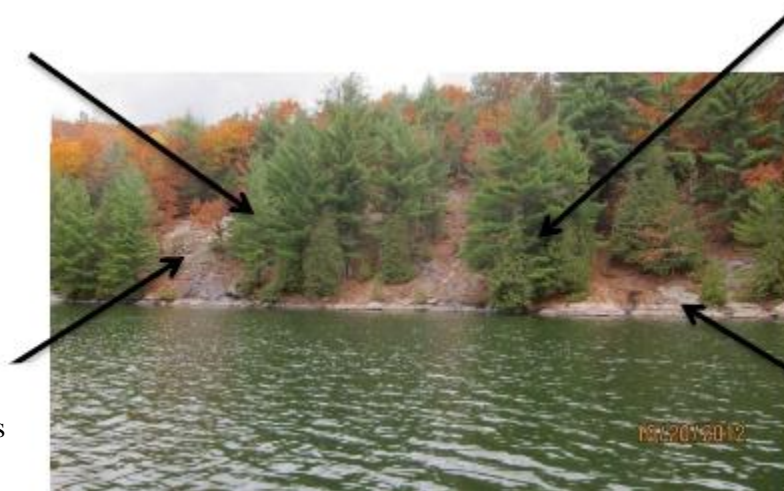
#### **Photo 1: Represents a shoreline with a classification score of (10/10)**

Site and Vegetation Cover: Approx. 90% natural, canopy cover nearly 100%. (10/10)

Structures: Shoreline has no breakwalls, piers or dock. (10/10)

Buffer Zone: Contains dense mature trees and understory. (10/10).

Littoral Zone: Contains a good amount of rocks, vegetation and woody debris. (10/10)

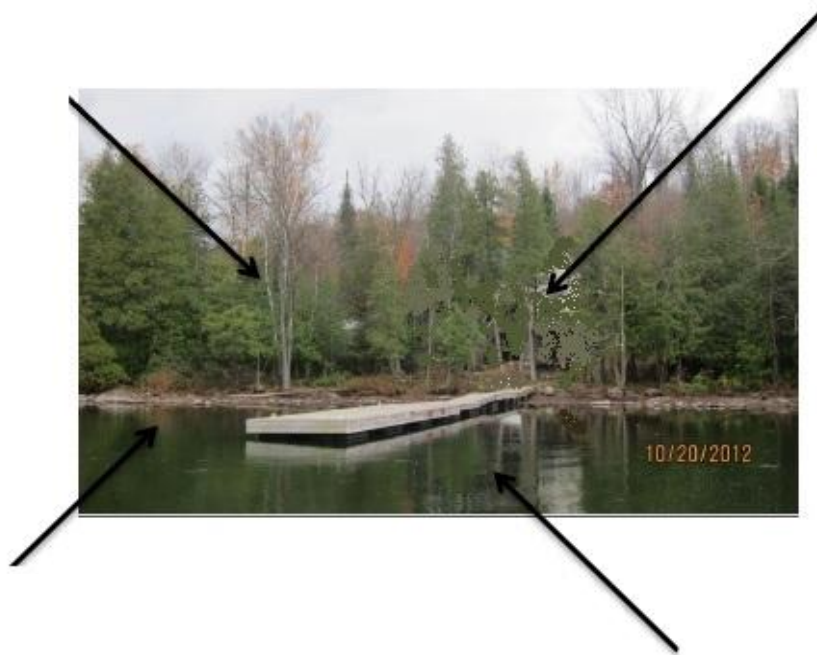
**Photo 2: Represents a shoreline with a classification score of (7.5/10)**

Little tree removal, canopy cover about 75%, minimum landscaping. (7.5/10)

Buffer Zone: Contains dense mature trees 3m from water's edge. (7/10)

Littoral Zone: Contains rocks and woody debris with minimum removal. (7/10)

Structures: Shoreline has temporary floating dock. (7/10)

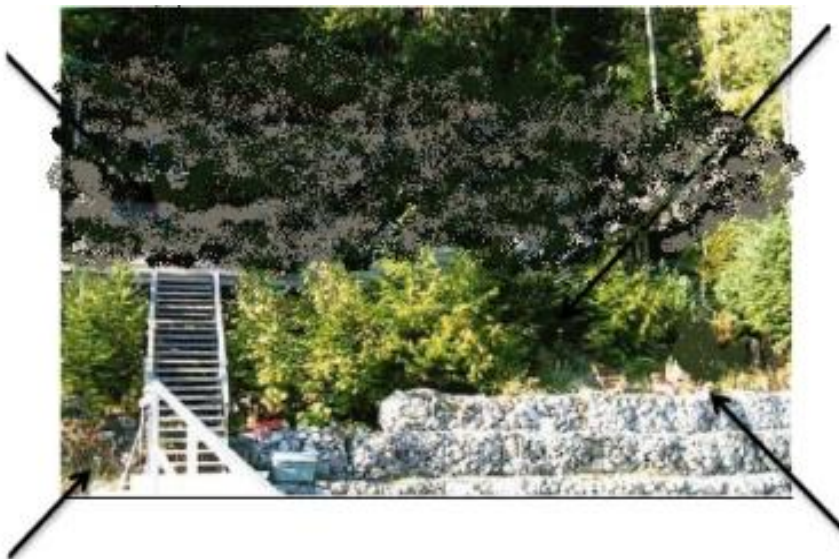
**Photo 3: Represents a shoreline with a classification score of (3/10)**

Cover: Large cottage with some landscaping, 50-70% deforested. (3/10)

Vegetation is patchy but there have been attempts to rehabilitate. (5/10)

Contains little woody debris evidence of rock, vegetation and woody debris removal. (3/10)

Combination of human constructions rockwall with docks. (1/10)
