## **Salerno (Devil's) Lake Shoreline Inventory Project**

Prepared by: Devon Fowler, 2012-2013

For: The Salerno (Devil's) Lake Cottagers' Association

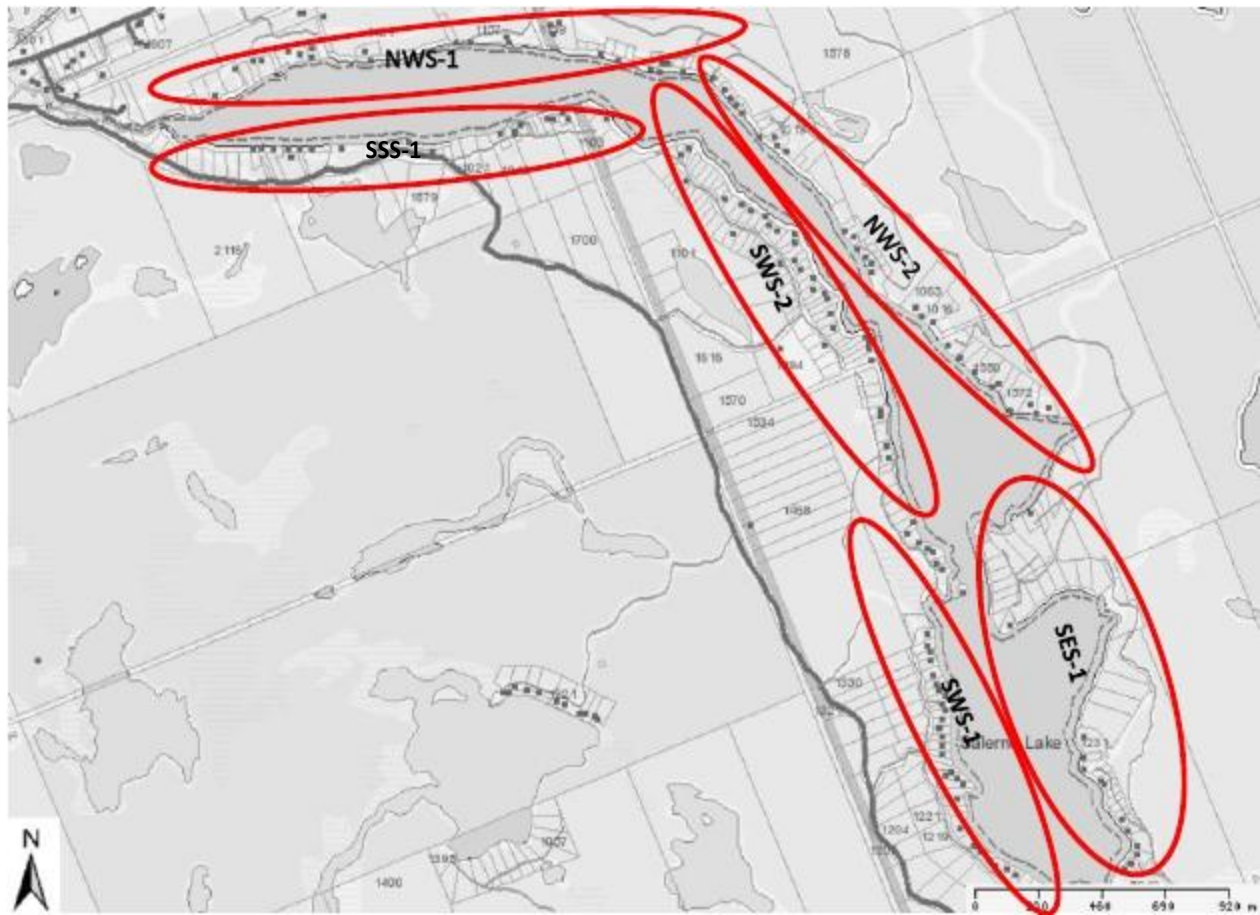
**Figure 1: Map Showing the Shoreline Zones on Salerno Lake**

*Table 1* summarizes all the zones identified along Salerno Lake. It demonstrates the breakdown as to how zones were identified from a larger section to a smaller portion of the shoreline.

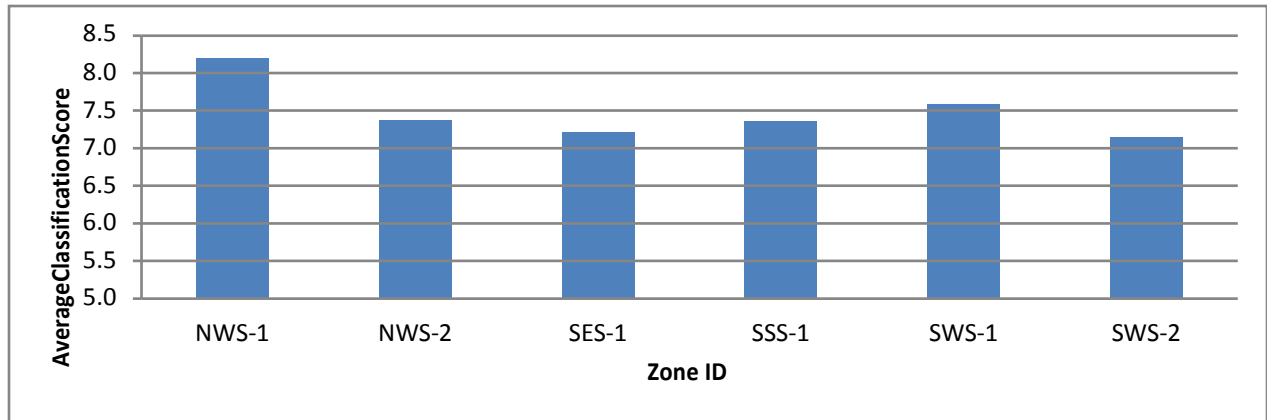
**Figure 2: Overall Average Classification Scores by Shoreline Zone**

Table 3 shows results of the average scores for each shoreline zone according to the SCS system. Overall the scores were relatively similar to one another with NWS-1 scoring the highest (8.1/10) possibly due to the amount of vacant lots found in that area, which tend to be associated with fairly high scores. Also it is the area that was first developed, so the properties tended towards smaller structures and more naturalist landscapes. The lowest score was found in SWS-2 with a score of 7.1/10. The scores are very ambiguous; it seems no significant area of the lake stands out in negative development.

The lowest average scores were for SES-1 with 7.2/10 and SWS-2 with 7.2/10. NSW-1 had the highest score at 8.1/10 most likely due to the very low number of populated properties; many of the properties are vacant or so large that only a small percentage of them are being used.

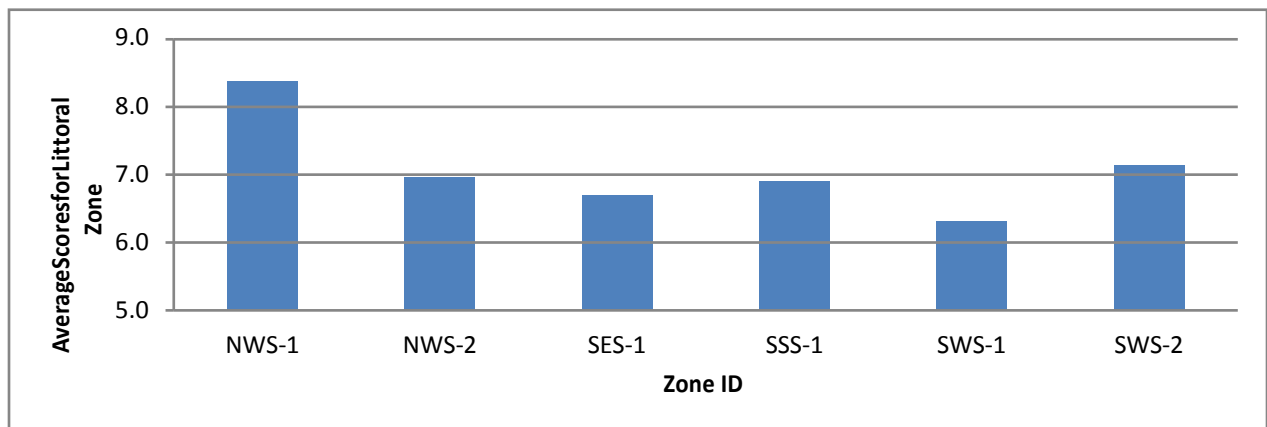
**Figure 3: Average Classification Scores for the Littoral Zone by Shoreline Zone**

There really is no significant difference in the shoreline scores when it comes to the littoral zone and the scores are all relatively high. The one exception being in the Zone of NWS-1(8.4/10), which due to the high number of vacant lots had a fairly natural shoreline.

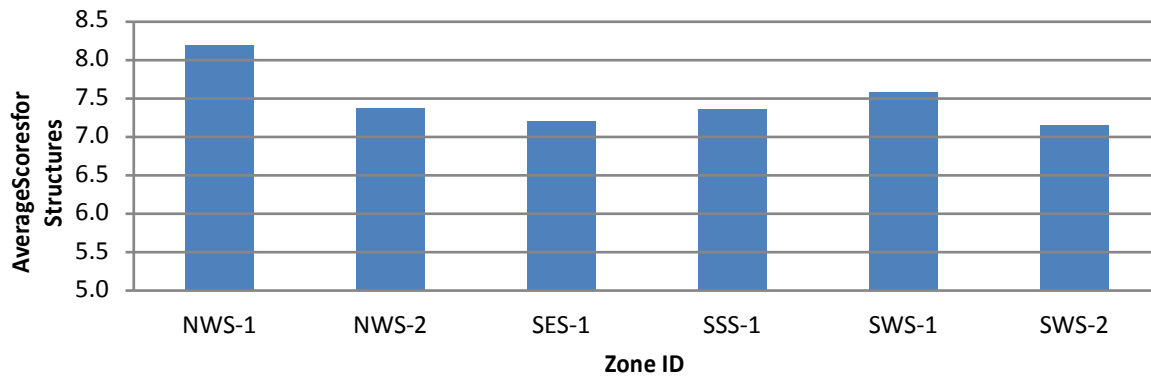
**Figure 4: Average Classification Scores for Structures by Shoreline Zone**

Many, with the exception of a few, of the cottages were moderately sized with floating docks or structures on stilts. Most docks were not excessively large, however as mentioned above this may be a misrepresentation due to the time of year of the inventory. The score for the shoreline correlate with the littoral zone in that scores were high and consistent across zones.

When replacing or building structures on your property; floating docks have the least amount of impact (Lakeland Alliance). The Lakeland Alliance in their “Shoreline owners guide to Lakeland living” state that floating docks are easy to build, cause very little disruption of the lake bed, minimal shading of aquatic plants and offer a free flow of water underneath.

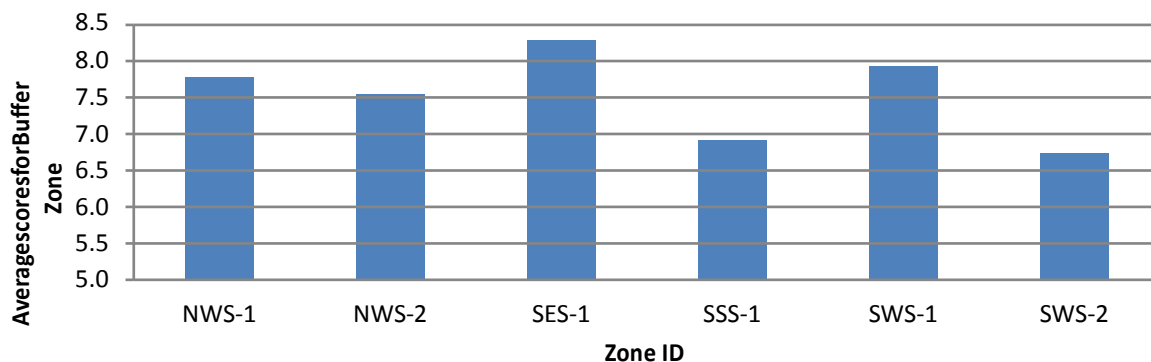
**Figure 5: Average Classification Scores for Buffer Zone by Shoreline Zone**

Buffer Zone scores were highest in the SES-1 region, and alternatively they were lowest in the SWS-2 region. Observations indicate that SWS-2 has, on average; the most developed and cleared buffer zones. There are some properties with man-made beaches which can deteriorate the buffer zone of a landscape rater rapidly. Also a grass lawn does not provide much in the way of buffering excess run of into the lake water, which may decline the surrounding water quality.

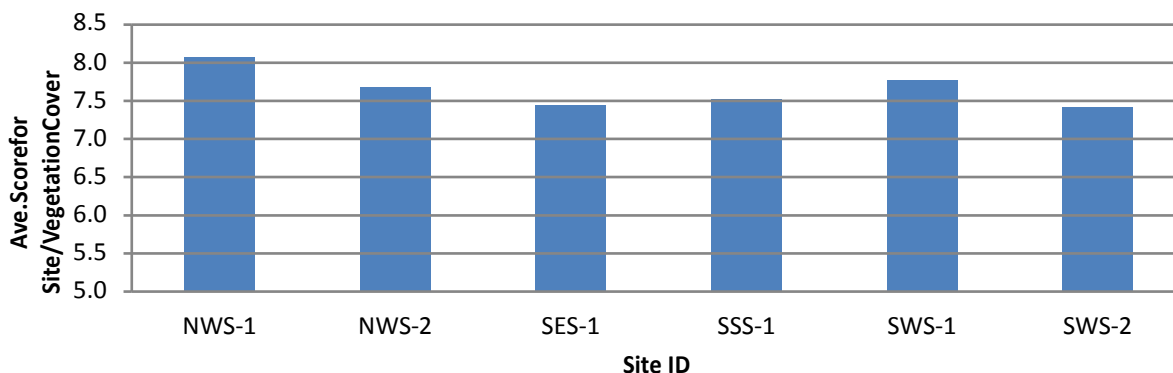
**Figure 6: Average Score for Site and Vegetation Cover by Shoreline Zone**

Figure 6- shows consistency in trends to many of the other figures. Again NWS-1 had the higher scores for reason consistent with what was mentioned above. Lowest scoring for site vegetation cover was in the SWS-2 zone which is consistent with the overall averaged lake scores; the lowest in almost every category.
